Routes of Aircraft Cabin Air Contamination from Engine Oil, Hydraulic and Deicing Fluid

DOI: 10.13111/2066-8201.2022.14.1.13

Abstract: *Purpose: This paper discusses potential contamination of the air in passenger aircraft cabins. It gives an overview of cabin air contamination basics. It further names possible contamination sources and possible routes of contamination. – Methodology: Evidence follows from a review of material found on the Internet and from the documentation of a visit to an aircraft recycling site. Parts were retrieved at the site and investigated later with more time. – Findings: Jet engine seals leak oil in small quantities. Metallic nanoparticles are found in the oil and have been detected in human fatty tissue of aviation workers. It has been observed that the potable water on board can also be contaminated. Oil traces have been found in bleed ducts, air conditioning components, and in air conditioning ducts. Deicing fluid and hydraulic fluid can find their way into the air conditioning system via the APU air intake. Fuel and oil also leak down onto the airport surfaces. These fluids can be ingested by the engine from the ground and can enter the air conditi

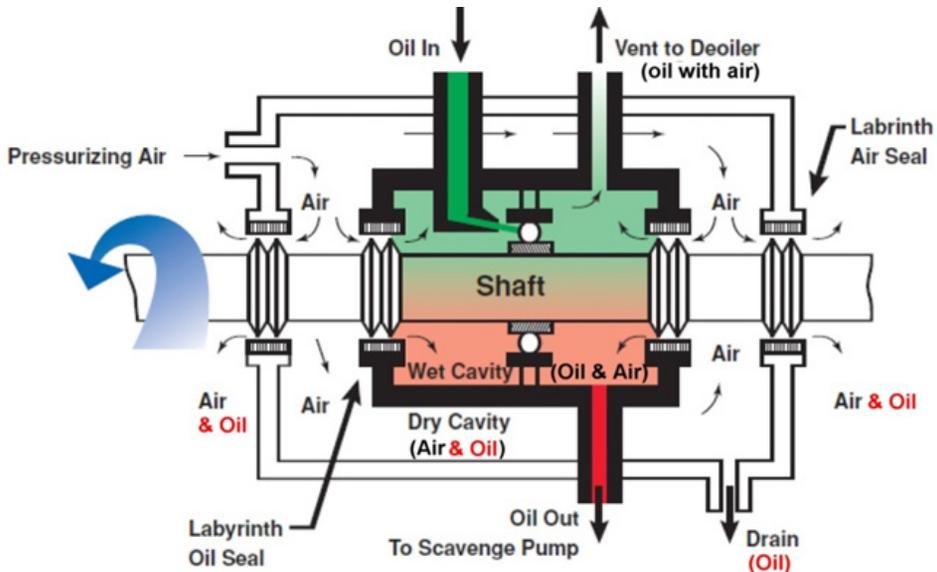
Fig. 3 - Lubrication and sealing of engine bearings (based on [7])

Even in normal operation, the engine seals leak small quantities of oil. This follows from Fig. 3 and these observations:

1. The "drain" discharges oil.
2. The "dry cavity" contains oil.
3. Air and oil leak from the bearing chamber into the air stream of the compressor and into the bleed air.

Accordingly, engines leak small amounts of oil by design. The oil with its toxic additives leaks into the compressor. It is pyrolyzed at the high air temperatures in the compressor leaving hundreds of organic substances behind some of which are toxic. Furthermore, the oil includes toxic metal nanoparticles – normal debris from the engine. These metal nanoparticles from the oil are finally found in the body of crew members as shown in the example of Fig. 4.

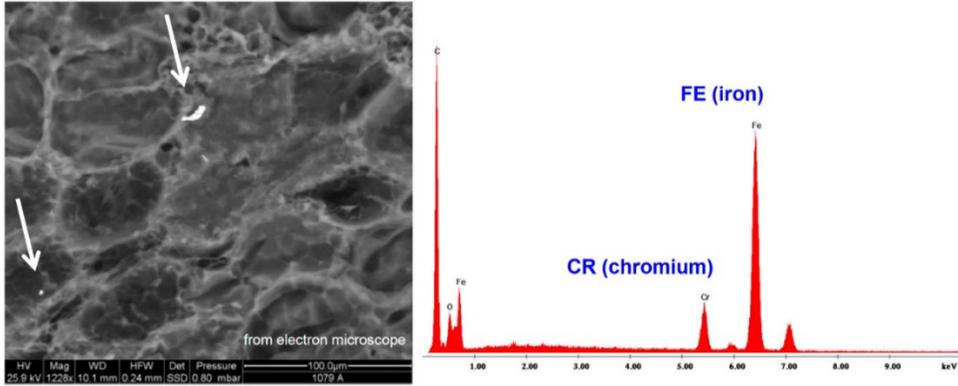
Fig. 4 - Left: High-magnification image (1228x) of human fatty tissue of a cockpit crew member showing a 10-micron (top) and a 1-micron (bottom, left) brighter-looking metal particle. Right: The EDS (Energy-Dispersive X-ray spectroscopy) spectrum analyzes the brighter-looking metal particles from the left picture, indicating carbon (C), iron (FE), chromium (CR) and Oxygen (O), hence a stainless-steel composition ([8], Analysis 8 of Table I, report written for client). The metal is probably debris from the engine transported with the oil into cabin and cockpit air

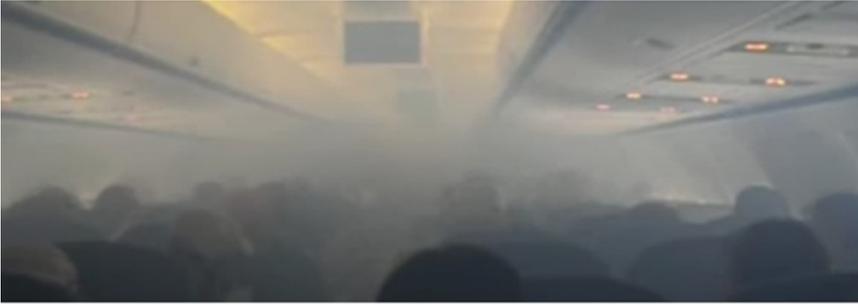
Fig. 6 - 2010-09-17, US Airways US-432, Boeing 757-200. Maui-bound flight enroute overhead the Pacific diverted to San Francisco (1200 nm). More: [9]. Picture source: Video: <https://youtu.be/AZqeA32Em2s>

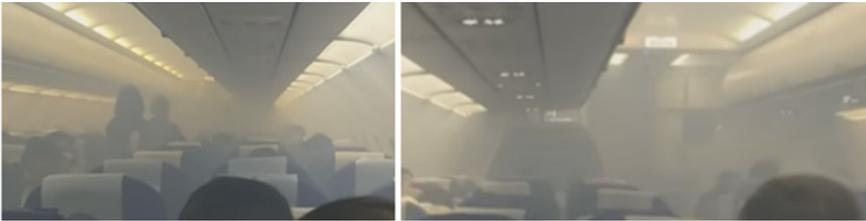
Fig. 7 - 2018-12-10, Indigo flight 6E-237, Airbus A320neo, Jaipur to Kolkata, India. The smoke was traced down to the engines (PW1127). This and more: [10]. Cause: Leakage of oil from the engine [11]. Picture source: Video: https://youtu.be/TO_FZ3L4yus

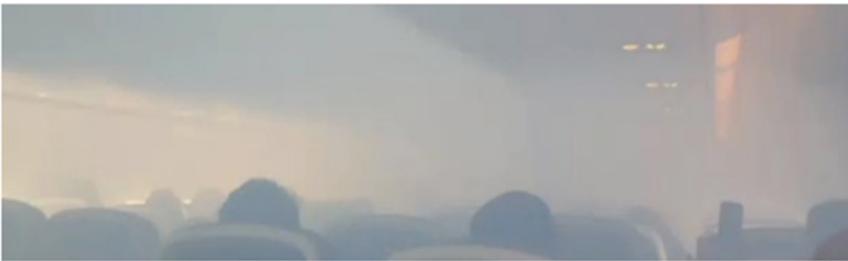
Fig. 8 - 2019-08-22, Hawaiian Airlines HA47, A321neo. Emergency landing and evacuation after smoke on board. Cause: Seal failure in left engine. Picture source: Glen Westenskow. This picture and more: [12]. More also on <https://purl.org/cabinair/HA47>

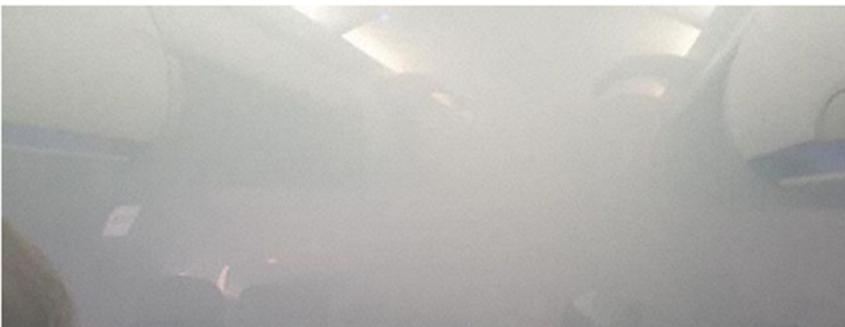
Fig. 9 - 2019-08-05, British Airways BA-422, Airbus A321. On a flight from London Heathrow to Valencia, the aircraft was descending towards Valencia when smoke appeared in the cabin. It followed an emergency evacuation. The aircraft remained 9 days in Valencia and was subsequently ferried to London. After a total of 31 days the aircraft returned back to service [13]. "It was found that no fire had occurred, but engine #2 (V2533, right hand) had lost all its oil. The engine was removed from the airframe and sent to the manufacturer for thorough inspection." This and more on: [14]. Picture source: Lucy Brown. Video: <https://youtu.be/tFsN0h09gAI>

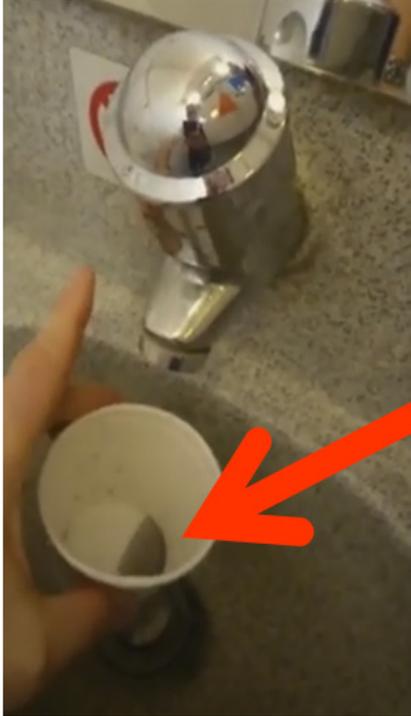
Compressed air from the engine is also used to pressurize the potable water tanks on some aircraft like the Airbus A320 [15]. It has been observed that the potable water on board can also be contaminated. Potable water contaminated by bleed air on an Airbus A320, is shown in Fig. 10. It is the last water extracted from the tank before it is empty. This water is black, probably from engine oil residue.

Fig. 10 - Potable water contaminated by bleed air on an Airbus A320. This is the last water extracted from the tank before it is empty. This water is black, probably from engine oil residue. Picture source is a Video: <https://youtu.be/dlPOeudTTCl>. The video is explained: On the A320 the potable water tank is pressurized with bleed air.

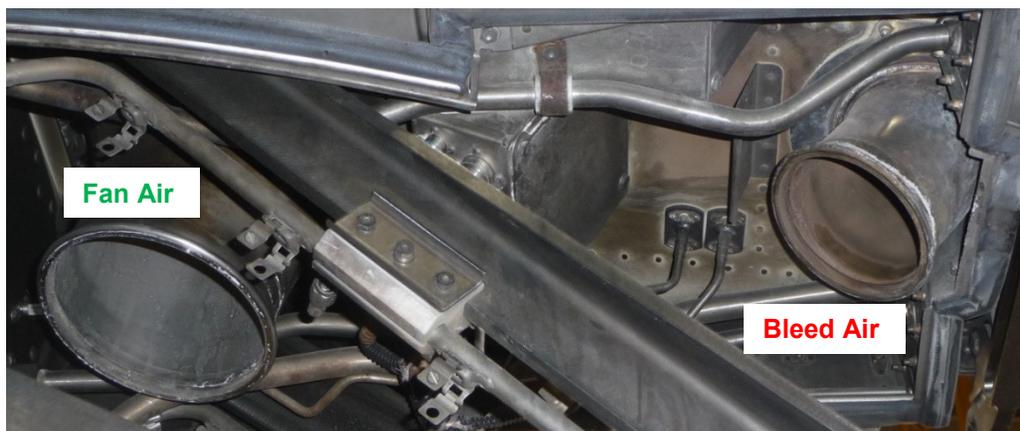
On the other hand, the bleed air is fresh outside air that has gone through the core of the engine. If everything were right, there should not be a difference depending on where the outside air gets compressed. Unfortunately, there is a difference. Bleed air is potentially contaminated with engine oil. This can be seen in Fig. 12. The fan air duct shows a normal metallic surface color, whereas the bleed air duct at the engine interface appears brown. The bleed air temperature at this point is about 300°C ... 400°C, the fan air is closer to ambient temperature. Metal on its own does not turn to a brown color when heated to 400°C. The only explanation with respect to the difference in the color of the two ducts is that the bleed air is covered by a brown residue. Confirmation comes from touching the surface. If not deposited in the duct, the substance causing the residue makes otherwise its way into the cabin. We know from engineering (Fig. 3) that jet engine seals leak oil by design. Therefore, the brown residue in the bleed air duct compared to the fan air duct is a confirmation that oil leakage takes place in the engine.

Fig. 12 - Bleed air duct with brown stain compared to a clean fan air duct on an Airbus A320

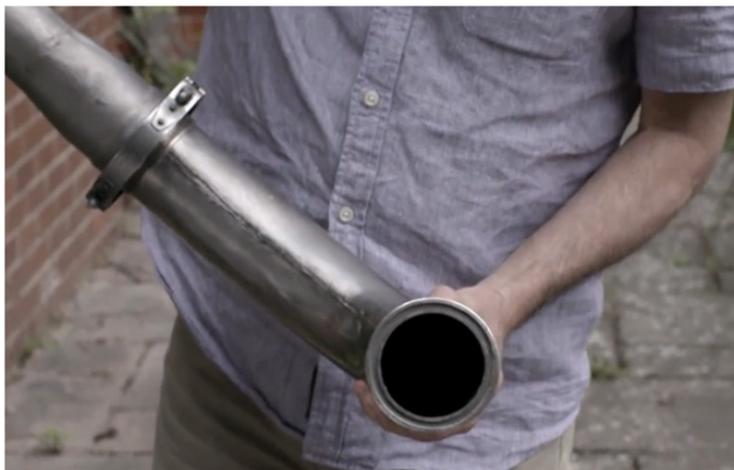
Ducting further downstream shows a black dry cover. The reason for the change in color seems to result from the different air temperatures: 400°C at engine outlet and 200°C further downstream behind the precooler. Fig. 13 shows a bleed air duct of a Boeing 737 with black oil residue inside.

Fig. 13 – Engine oil colors bleed air duct black (it is not just dark) from a Boeing 737. Picture source: Video: <https://vimeo.com/groups/617439/videos/345959025>

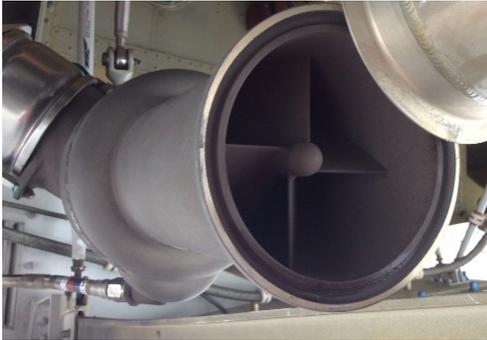
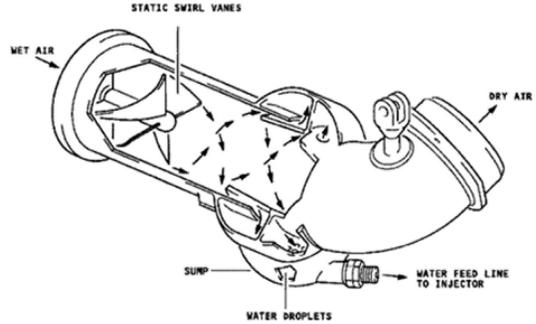
The water extractor is a part of the air conditioning pack. Fig. 14 shows the Airbus A320 water extractor, which is part of the air conditioning packs. The inlet of the water extractor is covered with black oily residue because the temperature is even lower at this point.

Fig. 14 - Engine oil residue accumulates in the water extractor. The schematic on the right is from [17]

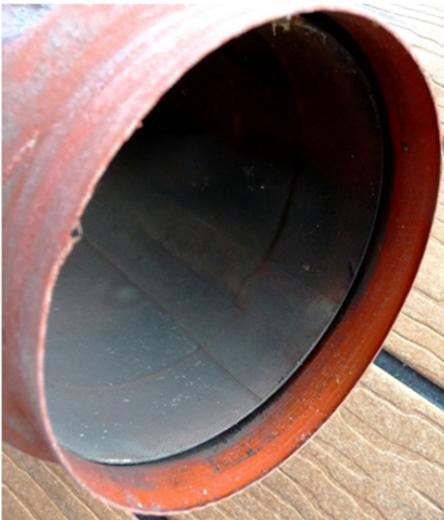
The air conditioning air distribution ducts in the cabin are black inside from contaminated bleed air. Fig. 15 shows the Airbus A320 air conditioning air distribution duct in the cabin. The inside is black from contaminated bleed air.

Fig. 15 - Airbus A320 air conditioning air distribution duct in the cabin

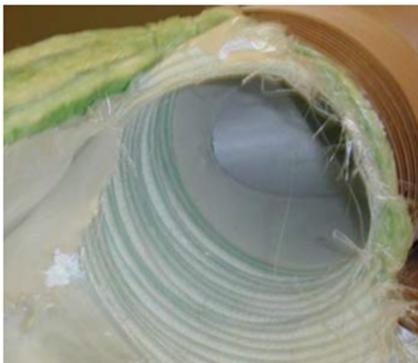
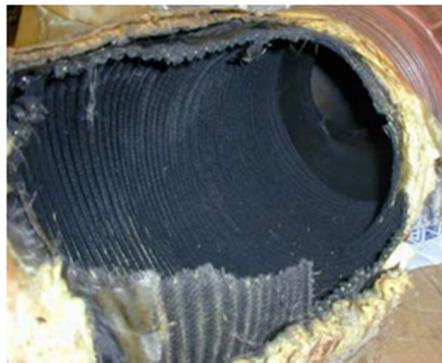
Fig. 16 shows on the left side an unused duct supplied new. The right side of Fig. 16 shows the same duct that had been installed downstream of the environmental control system air conditioning packs on a BAe 146 passenger aircraft after 26061 flight hours.

Fig. 16 - Left: Unused cabin air duct. Right: Used cabin air duct on a BAe 146 passenger aircraft [18]

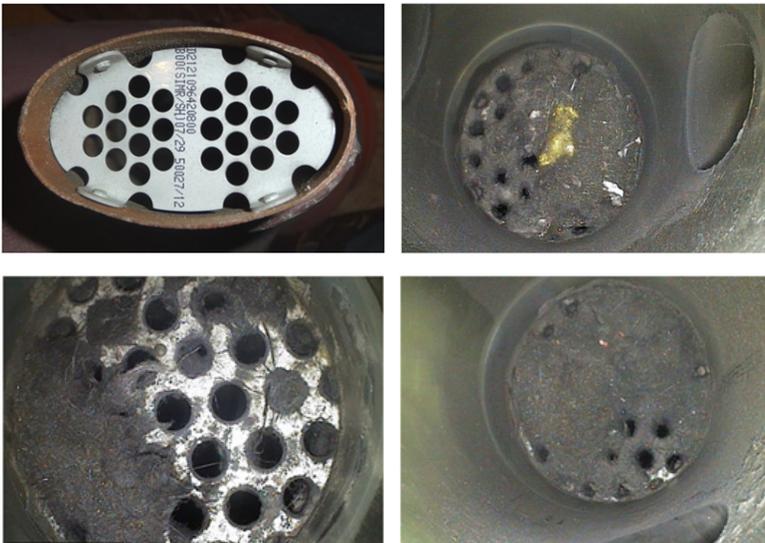
Flow limiters have been found in ducts of the air conditioning system clogged from engine oil. Fig. 18 shows flow limiters clogged from pyrolyzed engine oil in ducts of the air conditioning system of Boeing 757 aircraft with Rolls-Royce RB211-535E4 engines operated by Icelandair [19] compared to a clean flow limiter (top, left).

Fig. 18 - Top left: Clean flow limiter in an air conditioning duct on an Airbus A320 (here in a dead-end duct section installed for unknown reason) compared to flow limiters clogged from pyrolyzed engine oil in ducts of the air conditioning system of Boeing 757 aircraft [19]

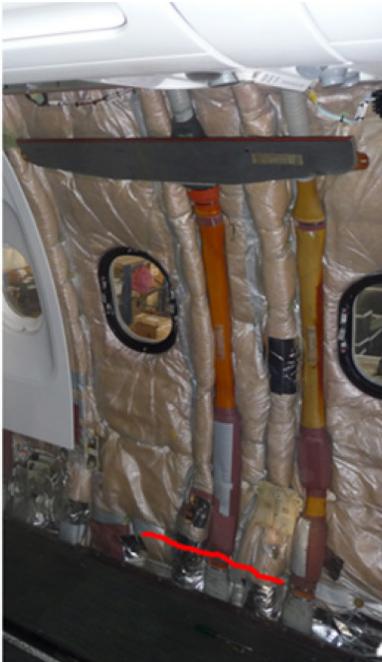
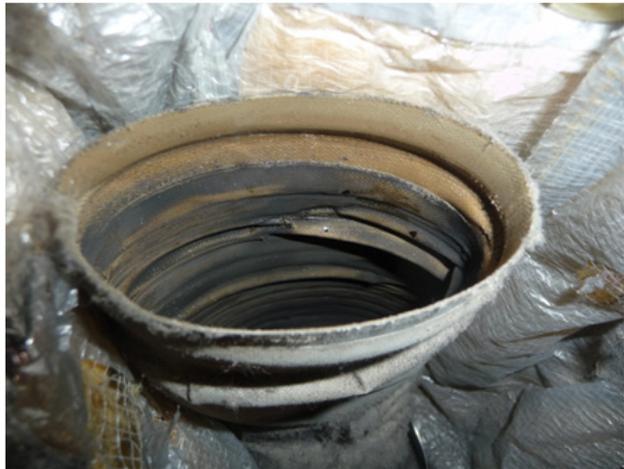
Fig. 19 shows the riser ducts and lower cabin air outlet on an Airbus A320 aircraft. The red line in Fig. 19 close to the cabin floor indicates where the duct was separated and opened. Looking down to the cabin floor shows a duct feeding the riser ducts. It is black inside from

Fig. 19 - Left: Riser ducts and lower cabin air outlet on an Airbus A320 aircraft. The red line close to the cabin floor shows, where the riser ducts are attached to their supply duct. See: Video: <https://youtu.be/jHG83gC6V4>. Top: View into the supply duct leading up into the riser duct on an Airbus A320. The inside is covered by a black residue

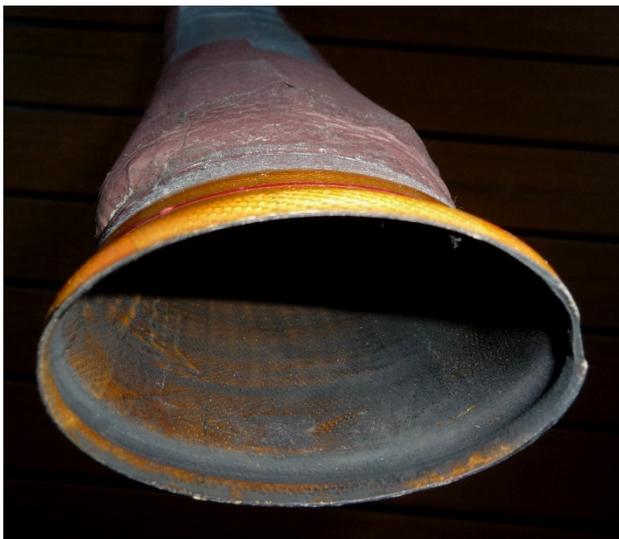
engine oil residue. Fig. 20 shows a view into the riser duct at that end, where it was separated at the cabin floor. It is also black inside.

Fig. 20 - View into the riser duct where it was separated at the cabin floor. It is covered inside by black residue

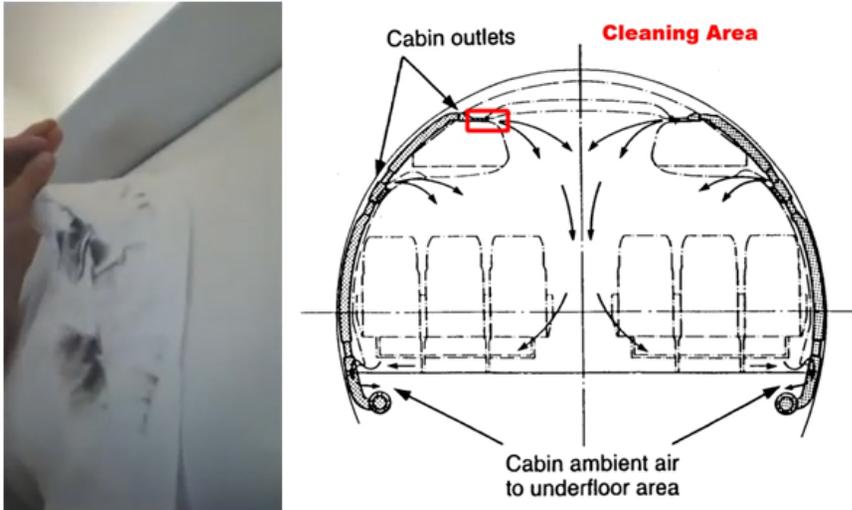
Cleaning on top of the overhead bins of an Airbus A320 brings to light dirt that is clearly more than dust. The black residue similar to that known from the ducts settles also on the bin surface, as shown on the left side of Fig. 21. The right side of Fig. 21 shows an Airbus A320 cabin cross section with the upper cabin air outlet releasing potentially contaminated air on top of the overhead bins.

Fig. 21 - Left: Cleaning on top of the overhead bins of an Airbus A320 brings to light dirt that is clearly more than dust. The black residue known from the ducts settles also on the bin surface. Picture source: Video: https://youtu.be/uQfA_DiMBS8. Right: Airbus A320 cabin cross section with the upper cabin air outlet releasing potentially contaminated air on top of the overhead bins (based on [17])

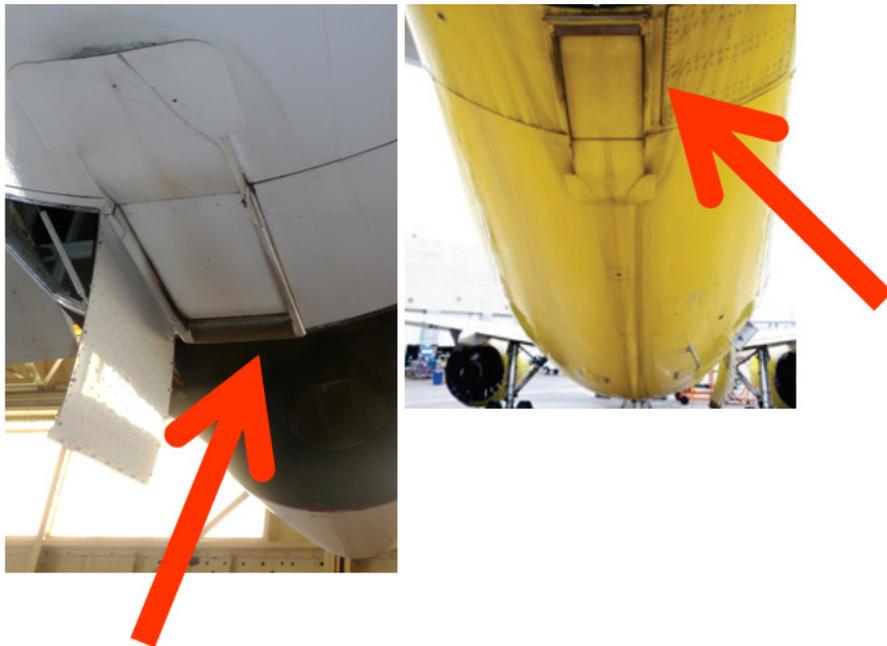
The left side of the Fig. 24 shows the air intake of the A320 APU. Fence and deflector around the APU air intake are clearly visible. These measures cannot fully prevent contaminants from entering the APU. On the right side of Fig. 24 traces of contamination are clearly visible on the lower part of the fuselage. Carried by the air flow in flight, the contaminants reach the APU inlet.

Fig. 24 - Air intake of the A320 APU. Source of picture on the right: [21]

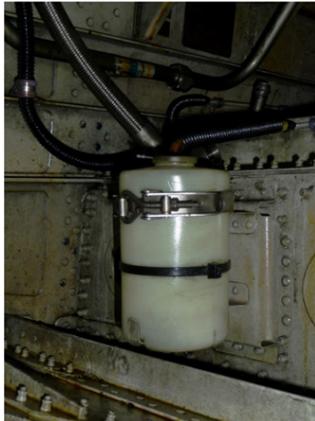
Fig. 26 - Aft collector tank of the A320 seal drain system, ATA 29-17. Forward and aft collector tanks collect hydraulic fluid from leaking equipment in the landing gear compartment, but spillover into the landing gear compartment when full. The photo tries to explain, what is meant with "the hydraulics industry must clean up its messy image". In this old Airbus A320, all surfaces in the landing gear bay are covered with a layer of hydraulic fluid. Dirt accumulates on the sticky surface. Logically, the hydraulic fluid is not confined to the inside of the hydraulic bay, but continues the lower side of the fuselage, if not cleaned constantly and finds its way to the APU inlet

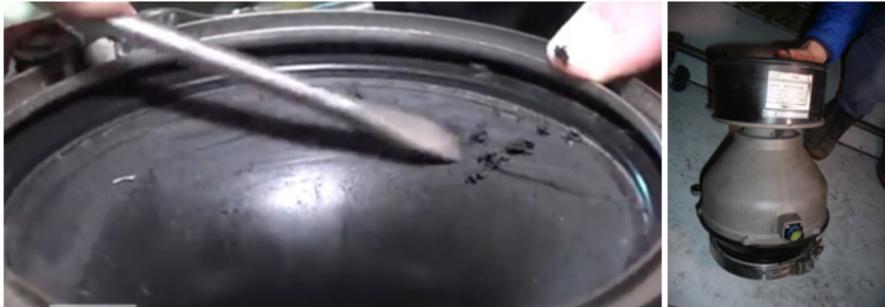
The location of the recirculation fan of an Airbus A320 is shown in Fig. 33. The face of the recirculation fan of an Airbus A320 is covered by an oily black soft substance that can be scraped off with a screwdriver (Fig. 34).

Fig. 34 - The recirculation fan of an Airbus A320 is covered by an oily black soft substance that can be scraped off with a screw driver. Picture source: Video: <https://youtu.be/jHGu83gC6V4>. A disassembled recirculation fan is shown on the right.

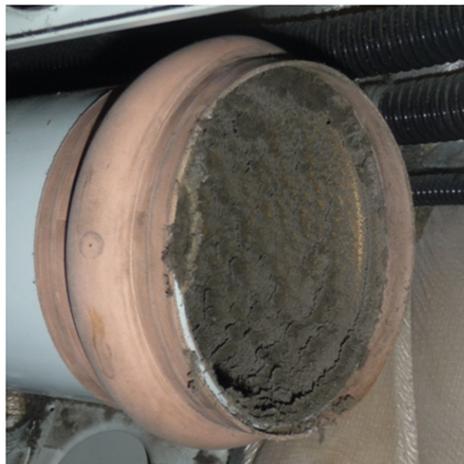
Fig. 35 shows the ambient air inlet in the cargo compartment of the Airbus A320 for cargo compartment heating and ventilation. The inlet is full of moist dust.

Fig. 35 - The ambient air inlet in the cargo compartment of the Airbus A320 for cargo compartment heating and ventilation. The inlet is full of moist dust
