Mechanical strength of the aircraft control chains in certain unusual cases

DOI: 10.13111/2066-8201.2023.15.4.21

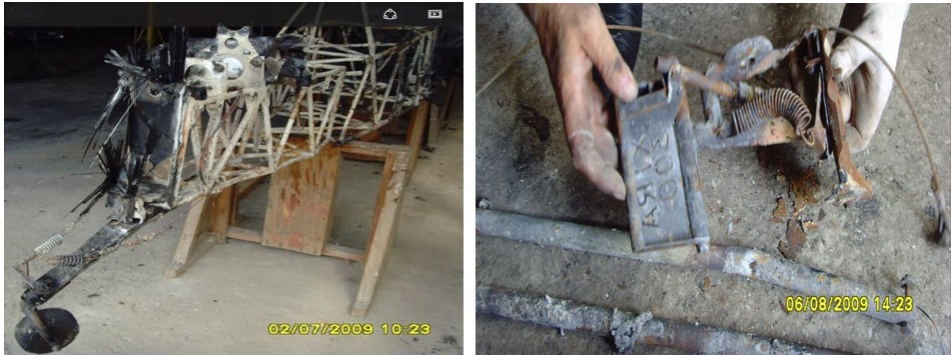
Fig. 5 The rudder and direction control chain

The cinematic chain of the rudder controlled was separated from the wrack and a metallographic analysis of it was conducted to determine the conditions of its destruction.

According to the cinematic scheme, the control chain consists of two working branches connecting the left and right pedal through the control cables and the rudder horizontal hinge lever. Applying a force on one of the working branches will generate an opposed force on the opposite branch. The value of the forces on the two branches is the result of the tensions that occurred in the system springs combined with the aerodynamic forces on the rudder surface.

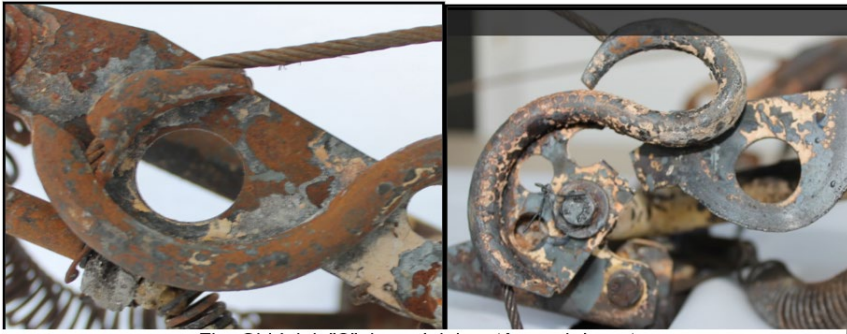
Fig. 7 The S-breakage of the left and right pedals

The analysis of the cinematic rudder control chain revealed operation abnormalities and braking of certain components. Just for reference the left pedal chain, which wasn't replaced, revealed significant friction traces and even some broken strands. These reveal very high strength in the cables or friction with the airframe parts.

During the investigation it was noticed that the S bracket of the right pedal cable was broken from the structure (broken weld), most probable due to the pilot effort to overrun the blockage of the left pedal. Even more, the left S-bracket showed a broken upper part denoting a high traction / stretching force applied to the cable, most probable due to blocking of the left pedal in the fuselage.

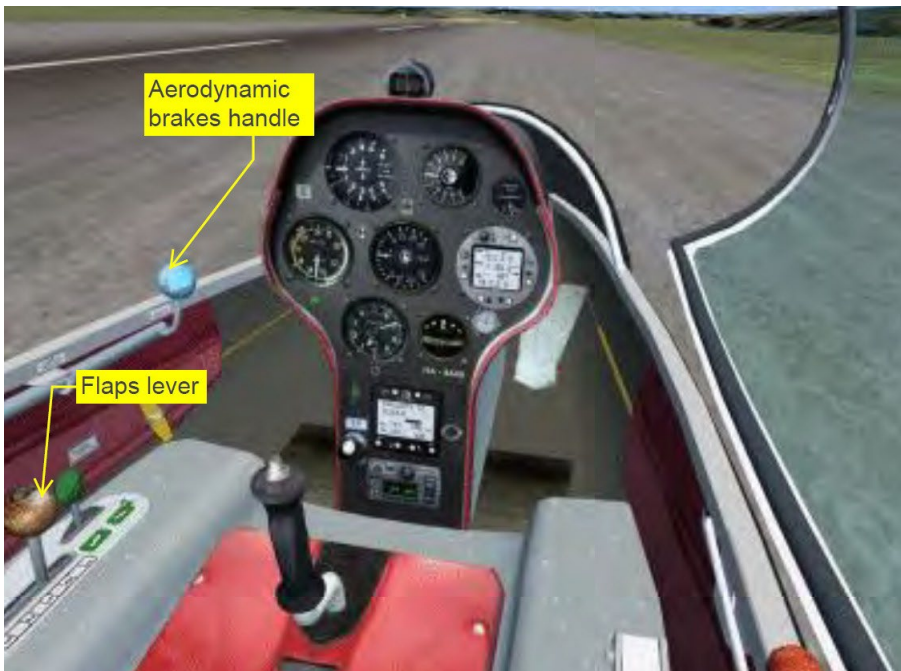
Fig 10 Panoramic view of the cockpit

By means of a lever in the cockpit on the left side panel, the flap is directly operated, through a mechanical system, by the pilot by placing the lever in the proper cut. The lever is shown in Figure 10.

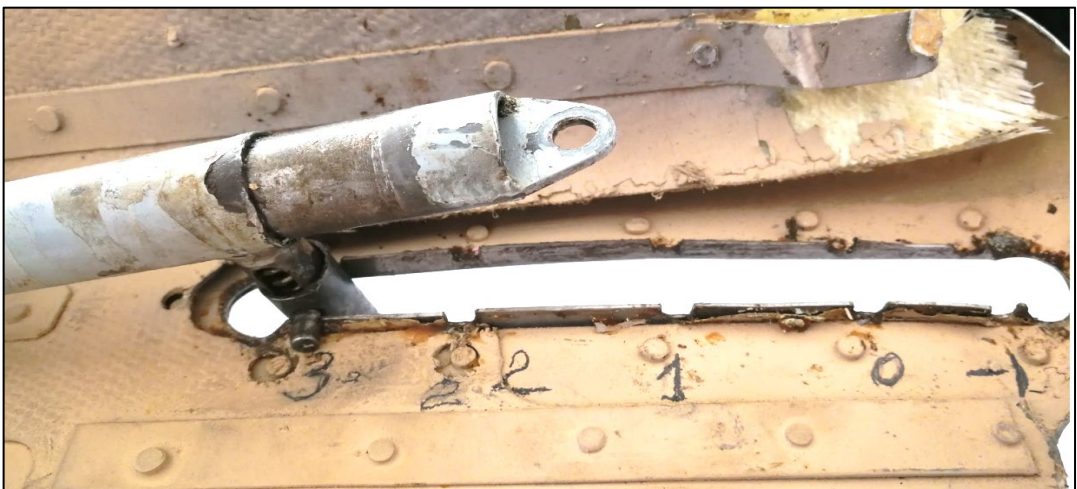
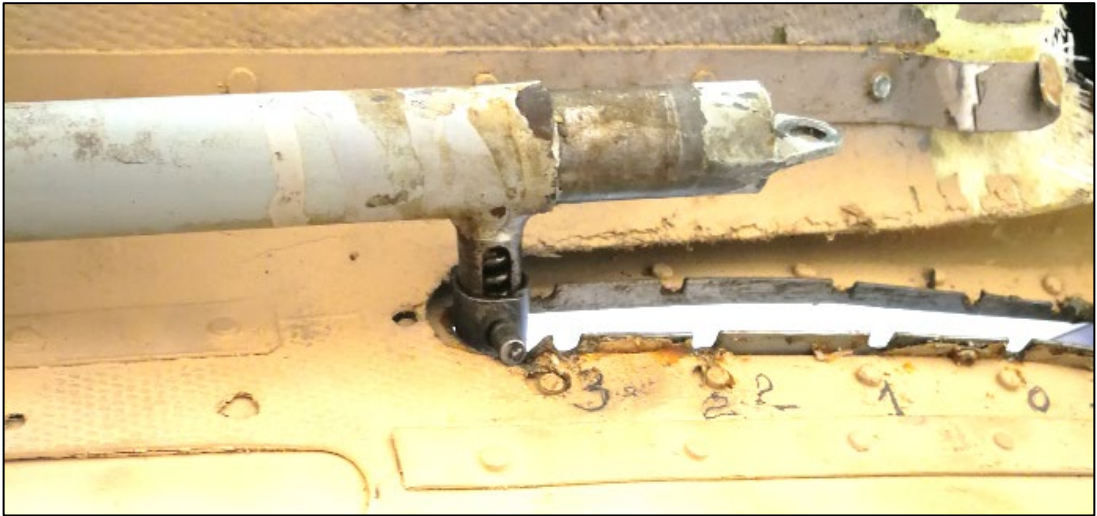
Fig. 11 Bottom views of the flaps lever positioning system

- the flap control lever was in position “1”;
 - advanced wear of the flap lever positioning cuts;
 - fake and unstable position of the control lever for the “Flap 3” and “Flap -1”, created by wear, in the process of in-flight operation, behind the normal cut for position “3” and in front of “-1”.

- accentuated wear of the “Flaps 2” position cut, compared to the normal position “3”. It can be identified the inappropriate fixing position behind the normal position 3, where the flap control lever is unstable.

- The cut for position 3 has much less wear than that of position 2 (considered as a reference), because most of the time the flap lever was positioned in the fake position „3”. The lever instability in this position was also accentuated by the accumulation of wear on the spring and the fixing pin.

- very advanced wear on the flap control lever fixing pin. The pin was not centered on the flap lever and had no stable position on the lever (it moved slightly left-right) in its lever positioning channel,

Under the influence of aerodynamic forces and due to malfunction of the positioning and safety system of the flap control lever, it frequently “jumps” from position “3” (sometimes also from position “2”) to the positions in front (1 and 0), uncontrollably modifying the glider aerodynamic characteristics, resulting in an unexpected increase in the stalling speed value.

The investigation found out that for gliders in newer manufacturing series than the glider in the accident, the manufacturer modified the constructive solution of the flaps control.
